1979 FASTNET RACE INQUIRY

ROYAL YACHTING ASSOCIATION. ROYAL OCEAN RACING CLUB
REPORT

BY
SIR HUGH FORBES SIR MAURICE LAING
LIEUTENANT-COLONEL JAMES MYATT
TO
THE COUNCIL OF THE RYA AND THE COMMITTEE OF THE RORC

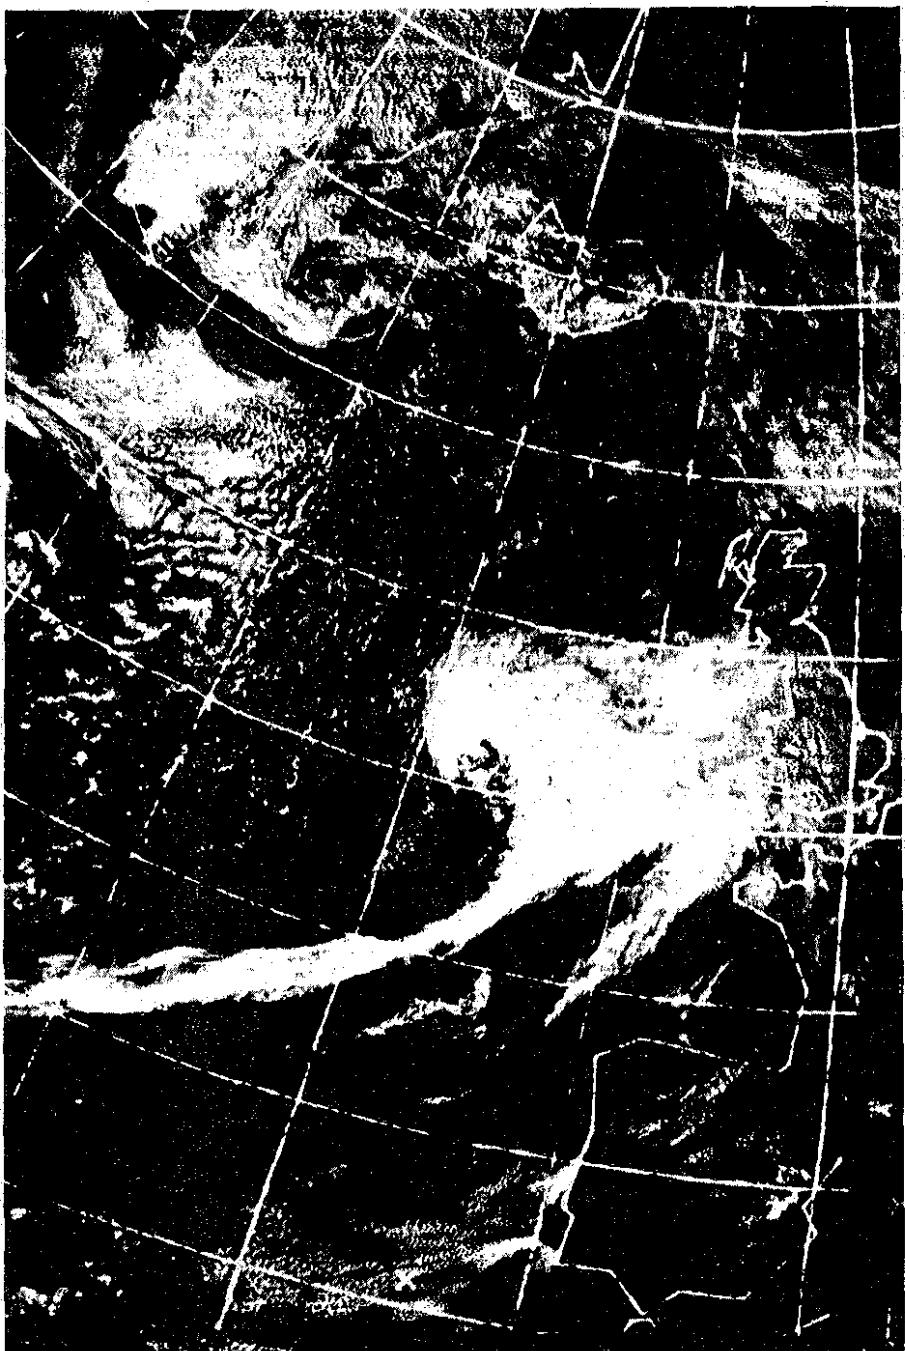
Fig. 3. How the TIROS N satellite saw the Fastnet low at 1837 on Monday. Reference to Fig. 1 will show where the low centre was at the time. The long tail of cloud lies along the cold front while thick cloud covers the centre off Ireland
